K-623

Old Millington Bank

Millington

# Maryland Historical Trust State Historic Sites Inventory Form

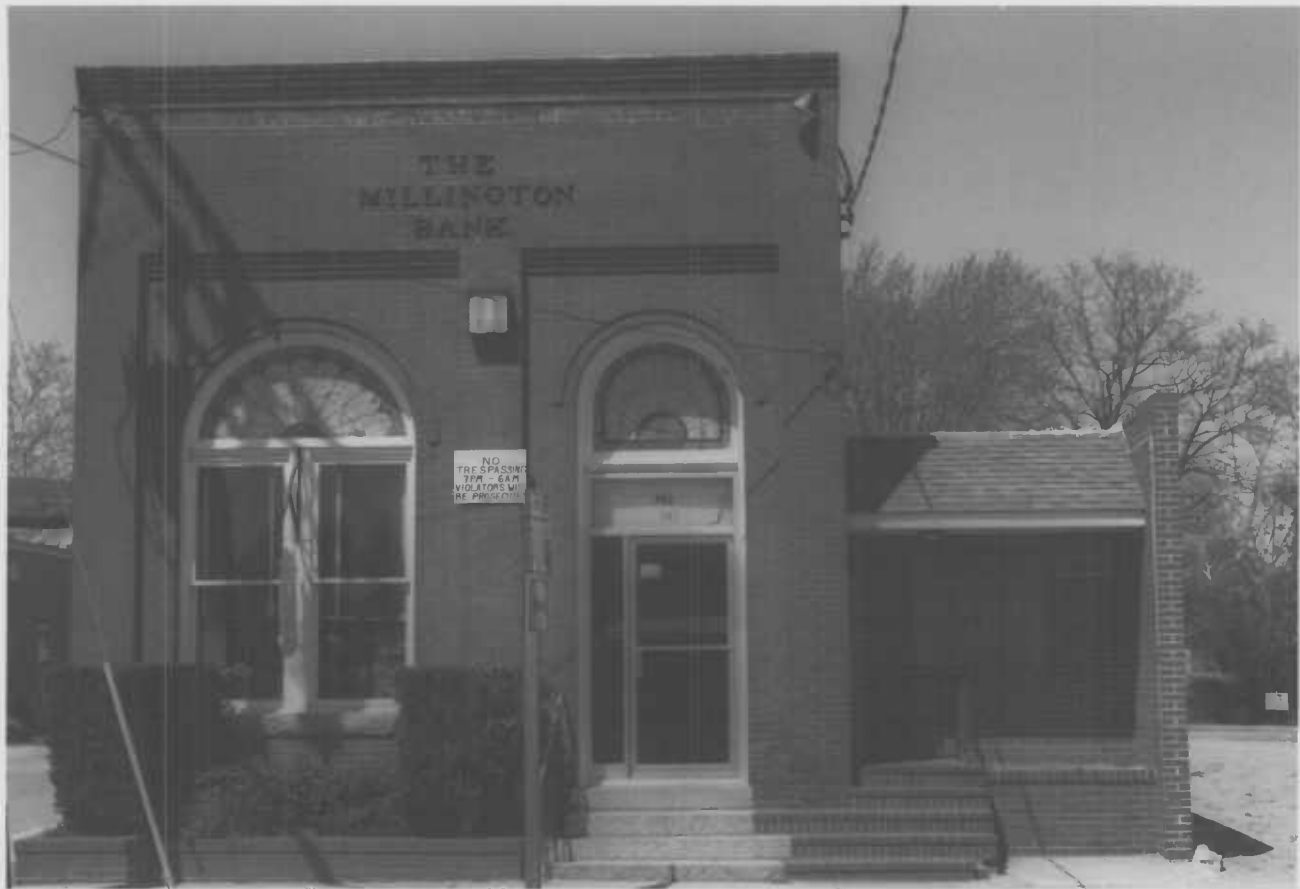
K 623 -9

K-623

Old Millington Bank

Cypress Street, Millington

M. Q. Fallaw - 4/23/86

View to north

The main entry is in the east bay of the south end. Leading to it are four wide granite steps, the top two narrower but deeper than the lower two. Above the top granite step there is now a terrazo sill, and the floor inside is similarly treated. There is a modern metal balustrade on the west side. These steps now adjoin and are continuous with the brick steps of the side wing. The entry architrave is about 15 feet high at the arch's apex. The door jambs are quite recessed beyond the face of the brick (about 5-1/2"). Everything below transom bar level has been replaced, probably in the 1950-1970 period. There is now a glass and mill-finish aluminum door with sidelight, very much  
(continued)

out of keeping with the architrave. Very likely double doors originally were in the c. 53" wide opening. The original transom bar remains. It is bold and compound, befitting the scale of the architrave. From the bottom, it includes dentils, a cyma reversa, fairly small cove with fillets, and a plain cap. The same bar is used at the paired windows. The stained glass in the entry arch is in a radial, or sunburst, pattern with central arch and outer arches similarly round-headed and repeating the theme. It is similar to but not the same as the glass of the nearby windows. Many somewhat muted, "marbelized" colors are used. The brick arch above the transom is of double headers, the inner one flush with the surrounding wall's brickwork, the outer one set out about 1", producing a somewhat prominent hooded appearance. The brick arch does not extend down to the transom, but only to the springing line. The brick arch of the double window does extend to that window's springing line, which is at the transom; its arch ends are lower than those of the entry.

The tall, paired windows with the arched transom in the facade west bay are double-hung with 1-over-1 lights. Between the windows there is a wide pilaster (7") from which now hangs a projecting sign denoting the town office. The window sills is massive and of granite, as the steps at the entry. It is 7" thick, with face rough and undressed. The architrave brick-mold edges are compoundly molded, with a small ovolo and bead at the inside corner. The stained glass of the transom, which is one unit above the double windows, is also in a radial (or fanlight) composition. From a dark-banded, dark-green center there are radial segments in white, gold, and other mottled or marbelized colors. There is an intermediate arch of elliptical purple segments. There is an outer bright blue border of large scallops with bright green infill.

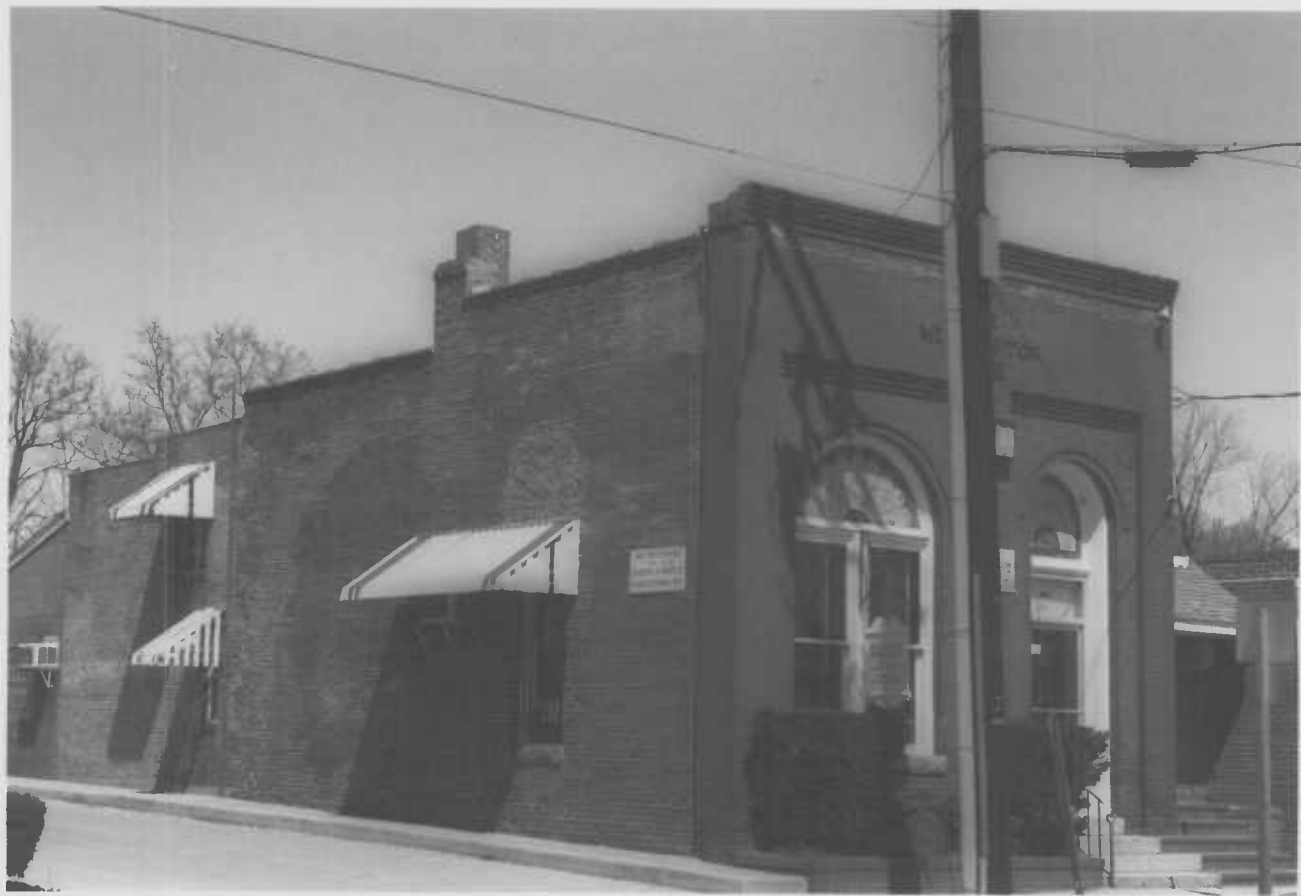
K-623

Old Millington Bank

M. Q. Fallaw - 4/23/86
